**From:** Waylon Denny [mailto:waylon.denny@bia.gov]  
**Sent:** Friday, August 14, 2015 11:42 AM  
**To:** Johnson, Tom <tojohns@southernute-nsn.gov>; Gurule, Kathi <kgurule@southernute-nsn.gov>; Hartenstine, Curtis <charten@southernute-nsn.gov>; Friedley, Jim <Jim.Friedley@bia.gov>  
**Subject:** East Mesa/Twin Rock/Animas Assessment

The purpose of this assessment was to evaluate site conditions at the following locations: **East Mesa/Twin Rock/Animas Irrigation System(s).**

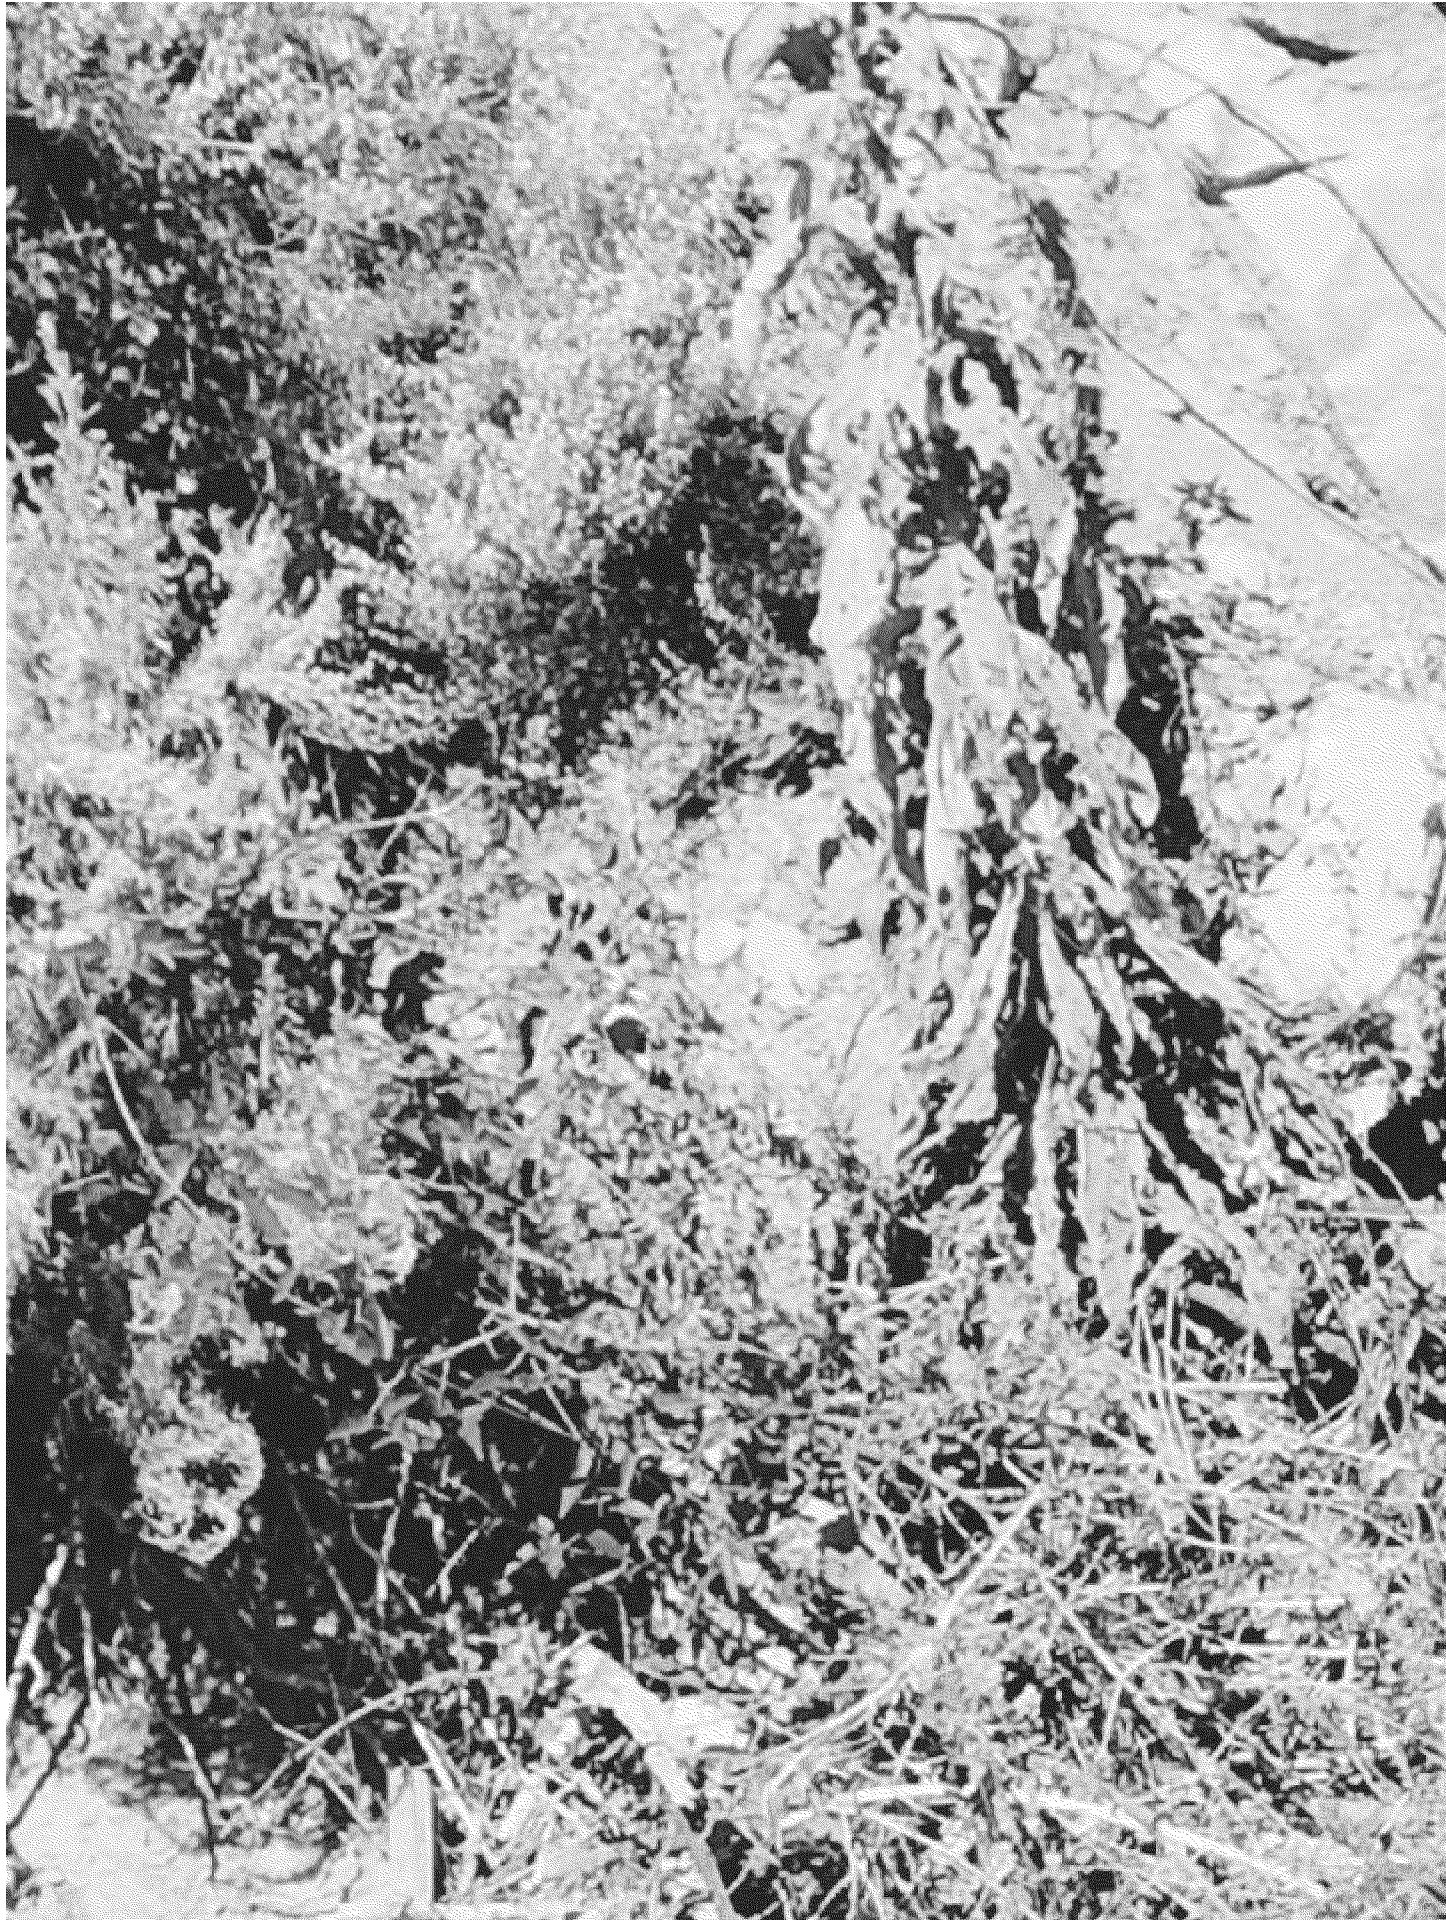
**Twin Rocks diversion** channel lie south and further downstream of East Mountain close to the New Mexico–Colorado state border. To the best of everyones knowledge these diversion gates were left open at the time the event occurred and water was allowed to flow back into the Animas River further downstream. Thick vegetation made assessment difficult but continuous flushing has occurred since the incident. As a result of this continuous flushing only minimal impacts were observed further downstream as the channel was reintroduced to the Animas River. BIA requested sediment samples at this location. BIA requested sediment samples be taken at both above the diversion and in the south ditch. Split-composite sediment samples were taken by the EPA contractor and by La Plata County water quality technicians.

**Recommendations:** Pending results of the composite-split sediment samples at these locations, it is my recommendation to continue to pass water through the irrigation ditches in order to allow any standing sedimentary accumulation the chance to enter back into the river ecosystem.
